RUST WARS

The Galvanic Force Awakens

By Brett Bultemeier - University of Florida

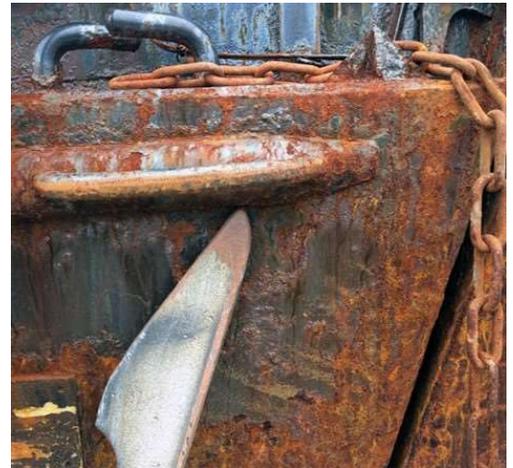
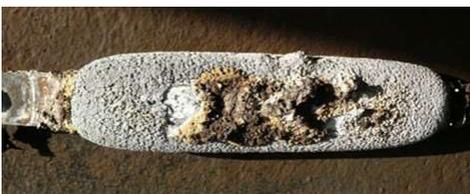
Modern boat hull and propeller construction involves the use of different types of metals that can act as either anodes or cathodes, with negative and positive charges, respectively. The basic formula for a working battery that electrons from an electrolyte solution (acid for batteries) flow from the anode to the cathode. For those who have seen the corrosion old batteries can cause, this is similar to the galvanization that can occur in boats. The hull of a boat is commonly aluminum, which carries a negative charge, whereas propellers and other boat parts are made of materials that carry positive charges. Water carries enough electrolytes (even freshwater) to create conditions for galvanic corrosion. Though saltwater is more commonly associated with this process, freshwater has enough dissolved minerals and particles with a charge to cause corrosion as well. Furthermore, stray current in the water, from powered boat docks or incorrect boat wiring, can further add to the corrosive forces acting on boats in freshwater.

A common way to minimize the corrosive effects on boats is to utilize sacrificial anodes made of zinc, aluminum or magnesium. These anodes preferentially absorb the charges and corrode first, which protects the more valuable metals such as the boat hull or propeller. This can either be passive or induced (with electricity), but the key piece is that these anodes MUST be in the water in

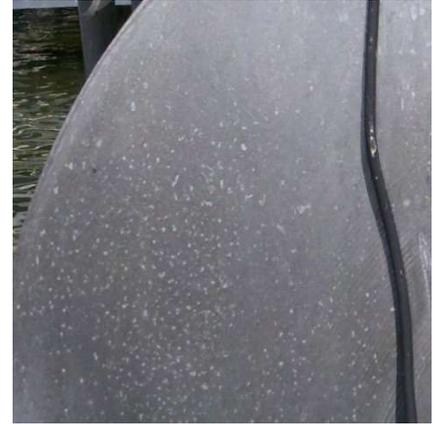
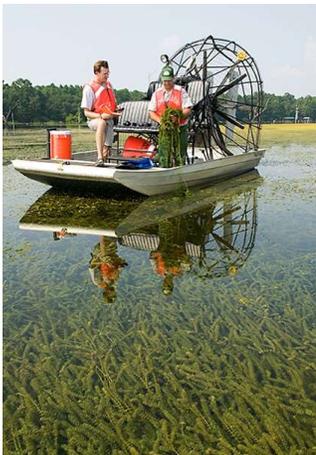
Sacrificial anode on a boat hull. Zwergelstern, distributed under a CC BY-SA 3.0 license.

Boat hull in the early stages of corrosion. Jim Donahoe, used with permission.

Many people believe that herbicides and algaecides have negative effects on their boat surfaces after they observe a chemical treatment taking place, become concerned about their boat, check the hull and find corrosion. It is likely that the corrosion was already there but went unnoticed until the boat owner checked the hull in response to seeing the weed management operation. If corrosion from herbicide and algaecide treatments were common, the boats used to apply the treatments would quickly corrode during the treatments, which is not what happens.
